REPORT NUMBER 214-GTL-04-003

**SAFETY COMPLIANCE TESTING FOR  
FMVSS NO. 214S  
SIDE IMPACT PROTECTION (STATIC)**

**GENERAL MOTORS CORP.  
2004 CHEVROLET MALIBU, PASSENGER CAR  
NHTSA NO. C40102**

**FINAL REPORT**

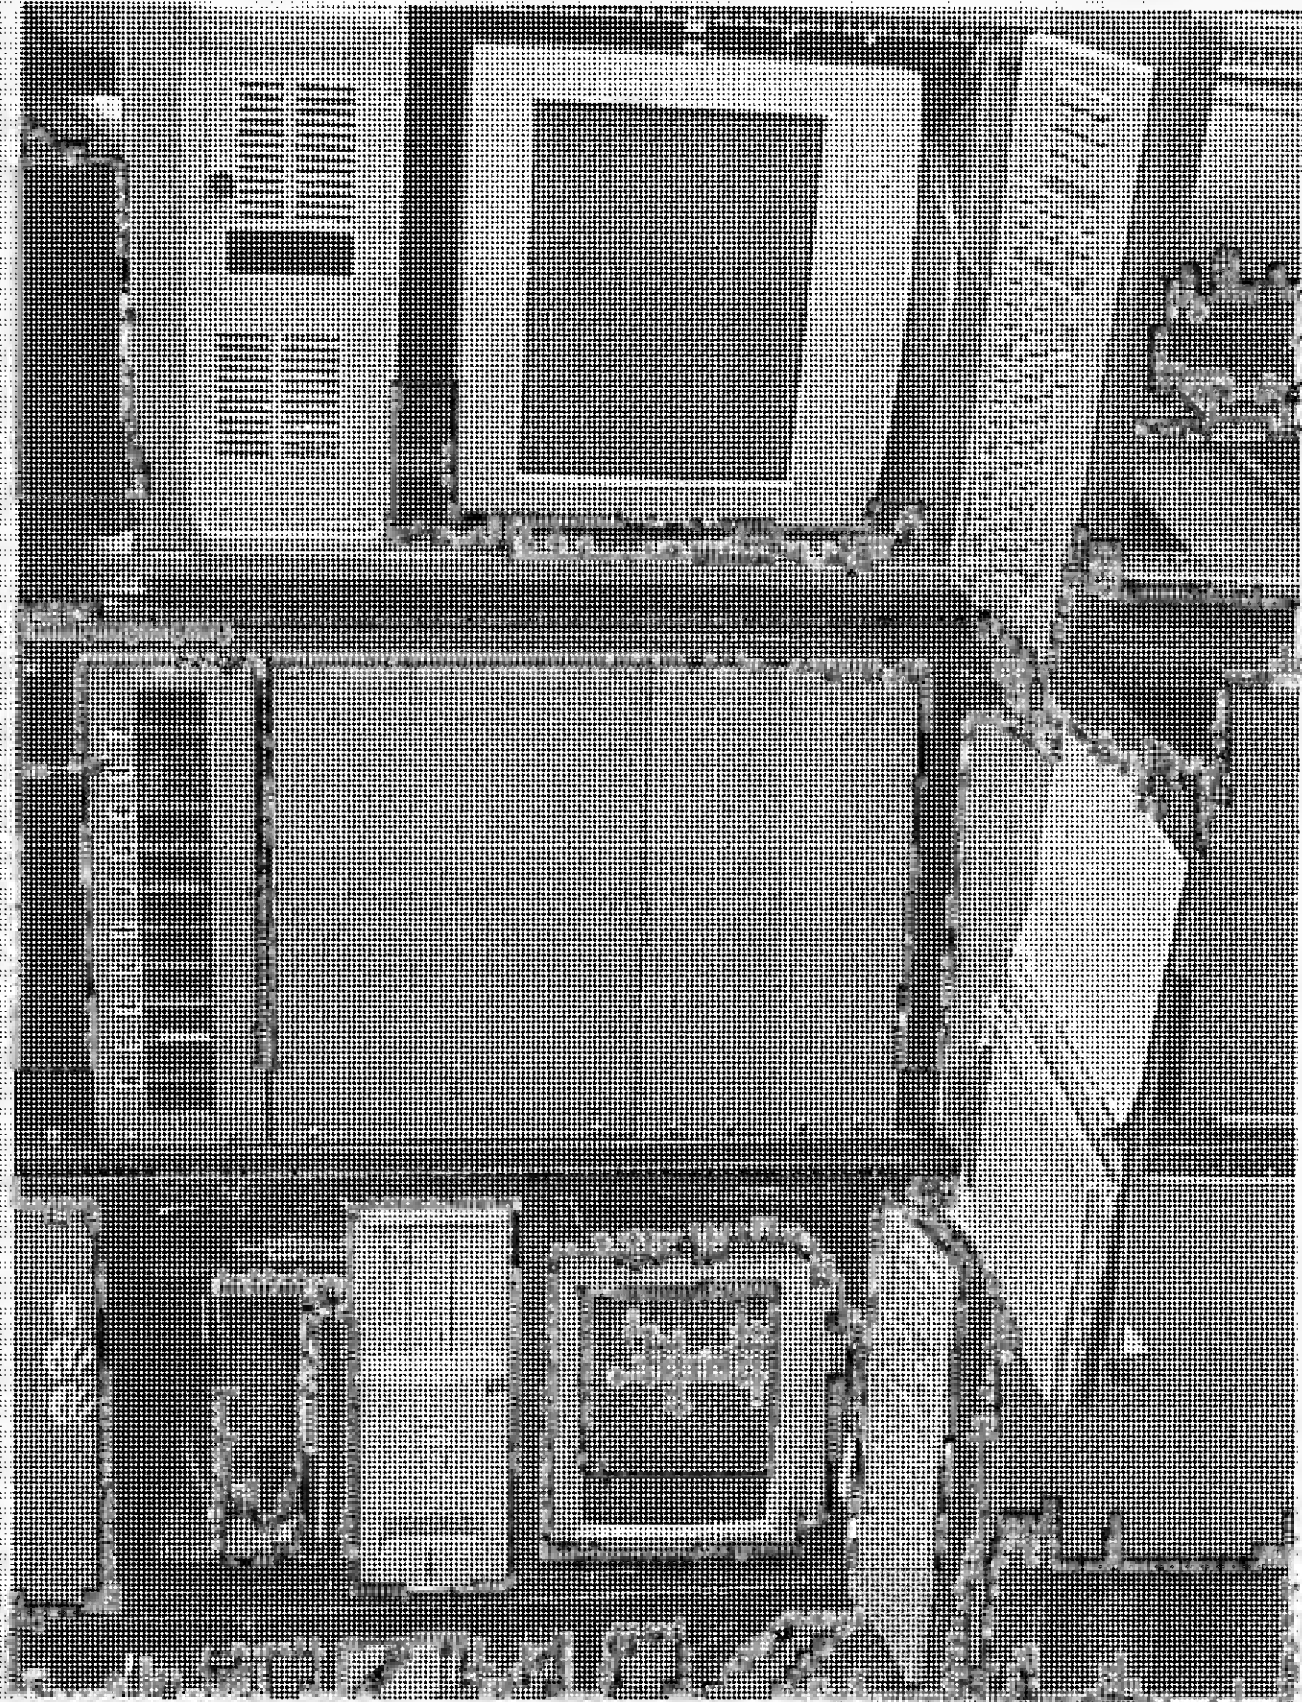
FIGURE 5.10  
INSTRUMENTATION SET-UP

EQUIPMENT	DESCRIPTION	MODEL/ SERIAL NO.	CAL. DATE	NEXT CAL. DATE
COMPUTER	AT&T	486DX266	N/A	N/A
TEST FIXTURE	GTL 220	220	N/A	N/A
A/D INTERFACE	METRABYTE	DAS-16(F)	BEFORE USE	BEFORE USE
SCALES	FAIRBANKS	N/A	BEFORE USE	BEFORE USE
SIGNAL CONDITIONER	METRABYTE	EXP-RES	BEFORE USE	BEFORE USE
LOAD CELLS	REVERE REVERE	544351A 544551B	11/03 11/03	11/04 11/04
LINEAR POT.	WALDALE WALDALE	123456A 123456B	BEFORE USE	BEFORE USE
INCLINOMETER	STARRETT	360/002	02/04	02/05
DIAL INDICATOR	MIOTO	0001-2	BEFORE USE	BEFORE USE

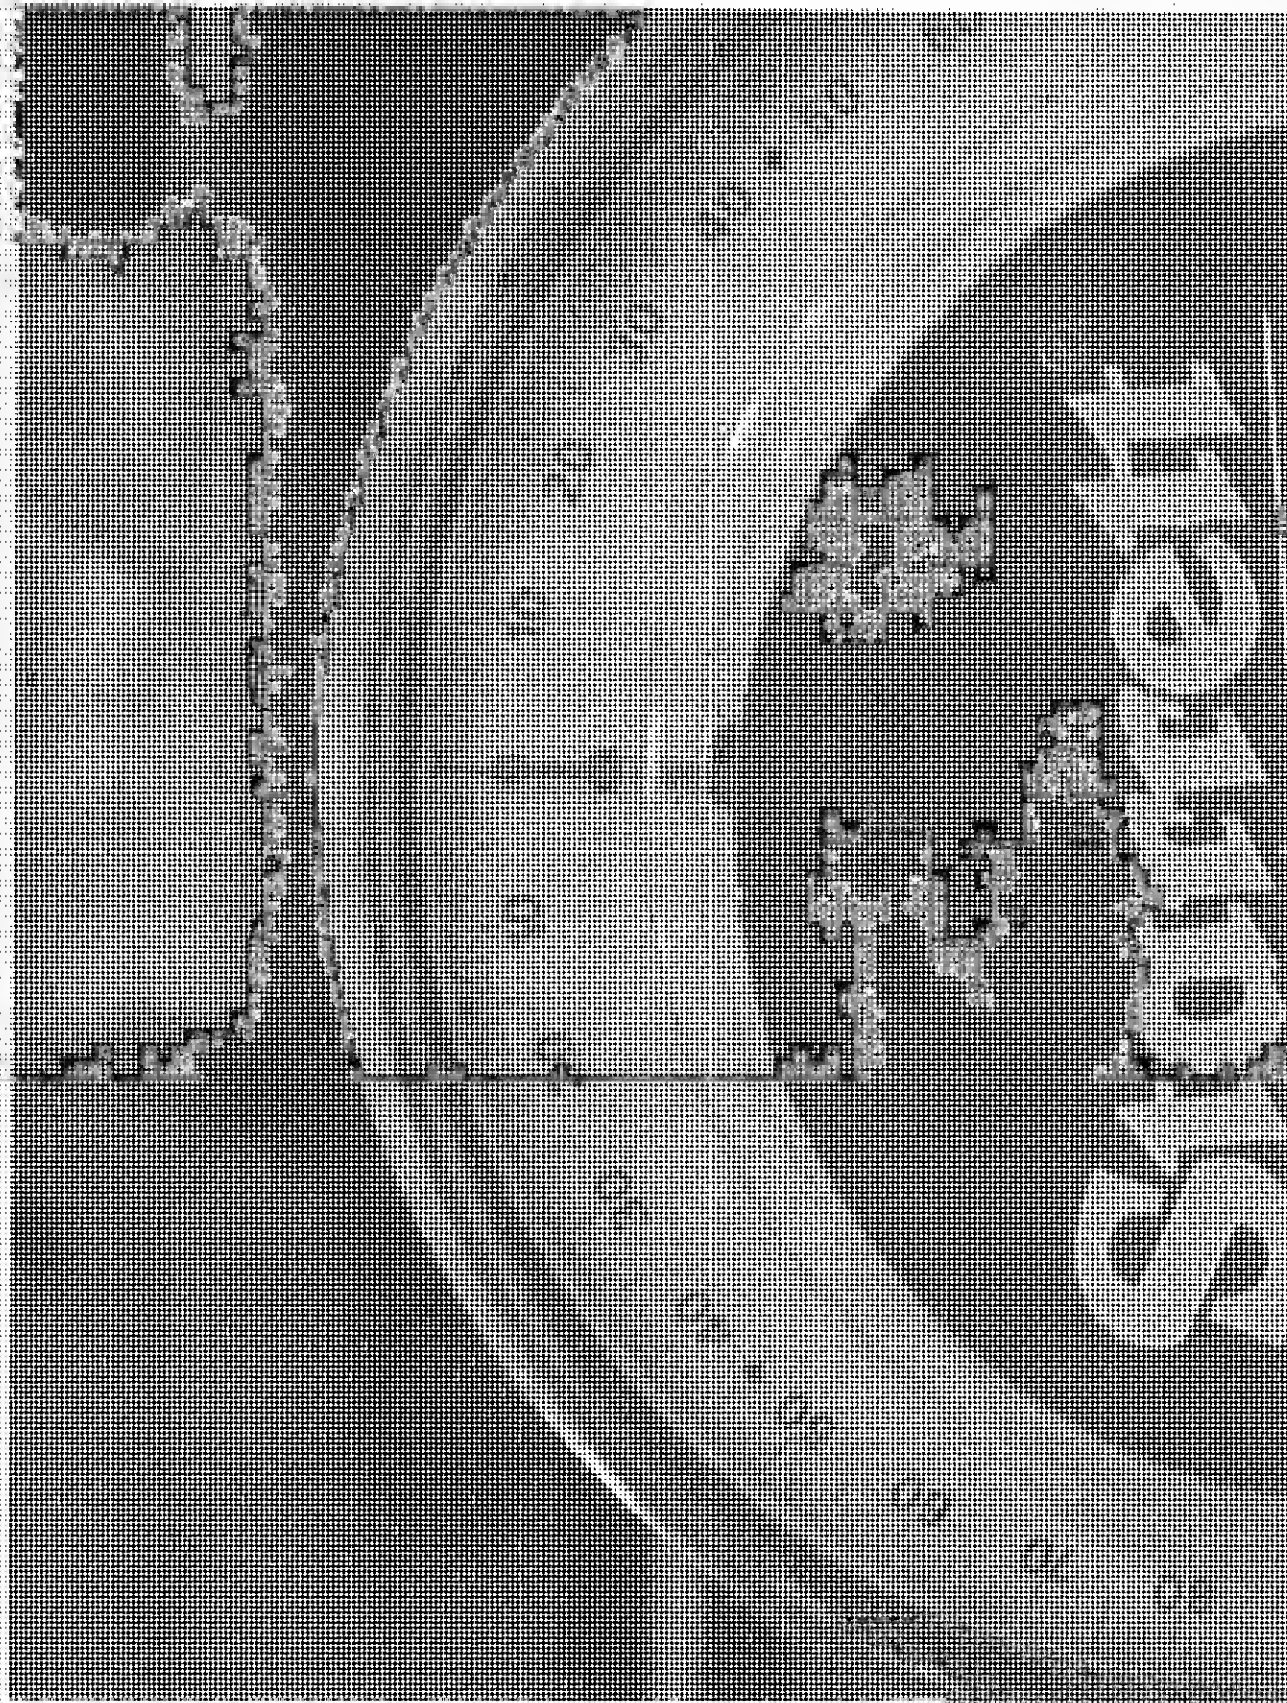
FIGURE 5.13  
INCLINOMETER PRE-TEST 1

LOADING DEVICE TRAVEL	DIAL INDICATOR	INCLINOMETER
0 inches	<u>0.0000</u>	<u>0</u>
2 inches	<u>0.0279</u>	<u>0</u>
4 inches	<u>0.1432</u>	<u>0</u>
6 inches	<u>0.1823</u>	<u>0</u>
12 inches	<u>0.6021</u>	<u>0</u>
<u>12.003</u> Inches (full travel)	<u>0.6088</u>	<u>0</u>

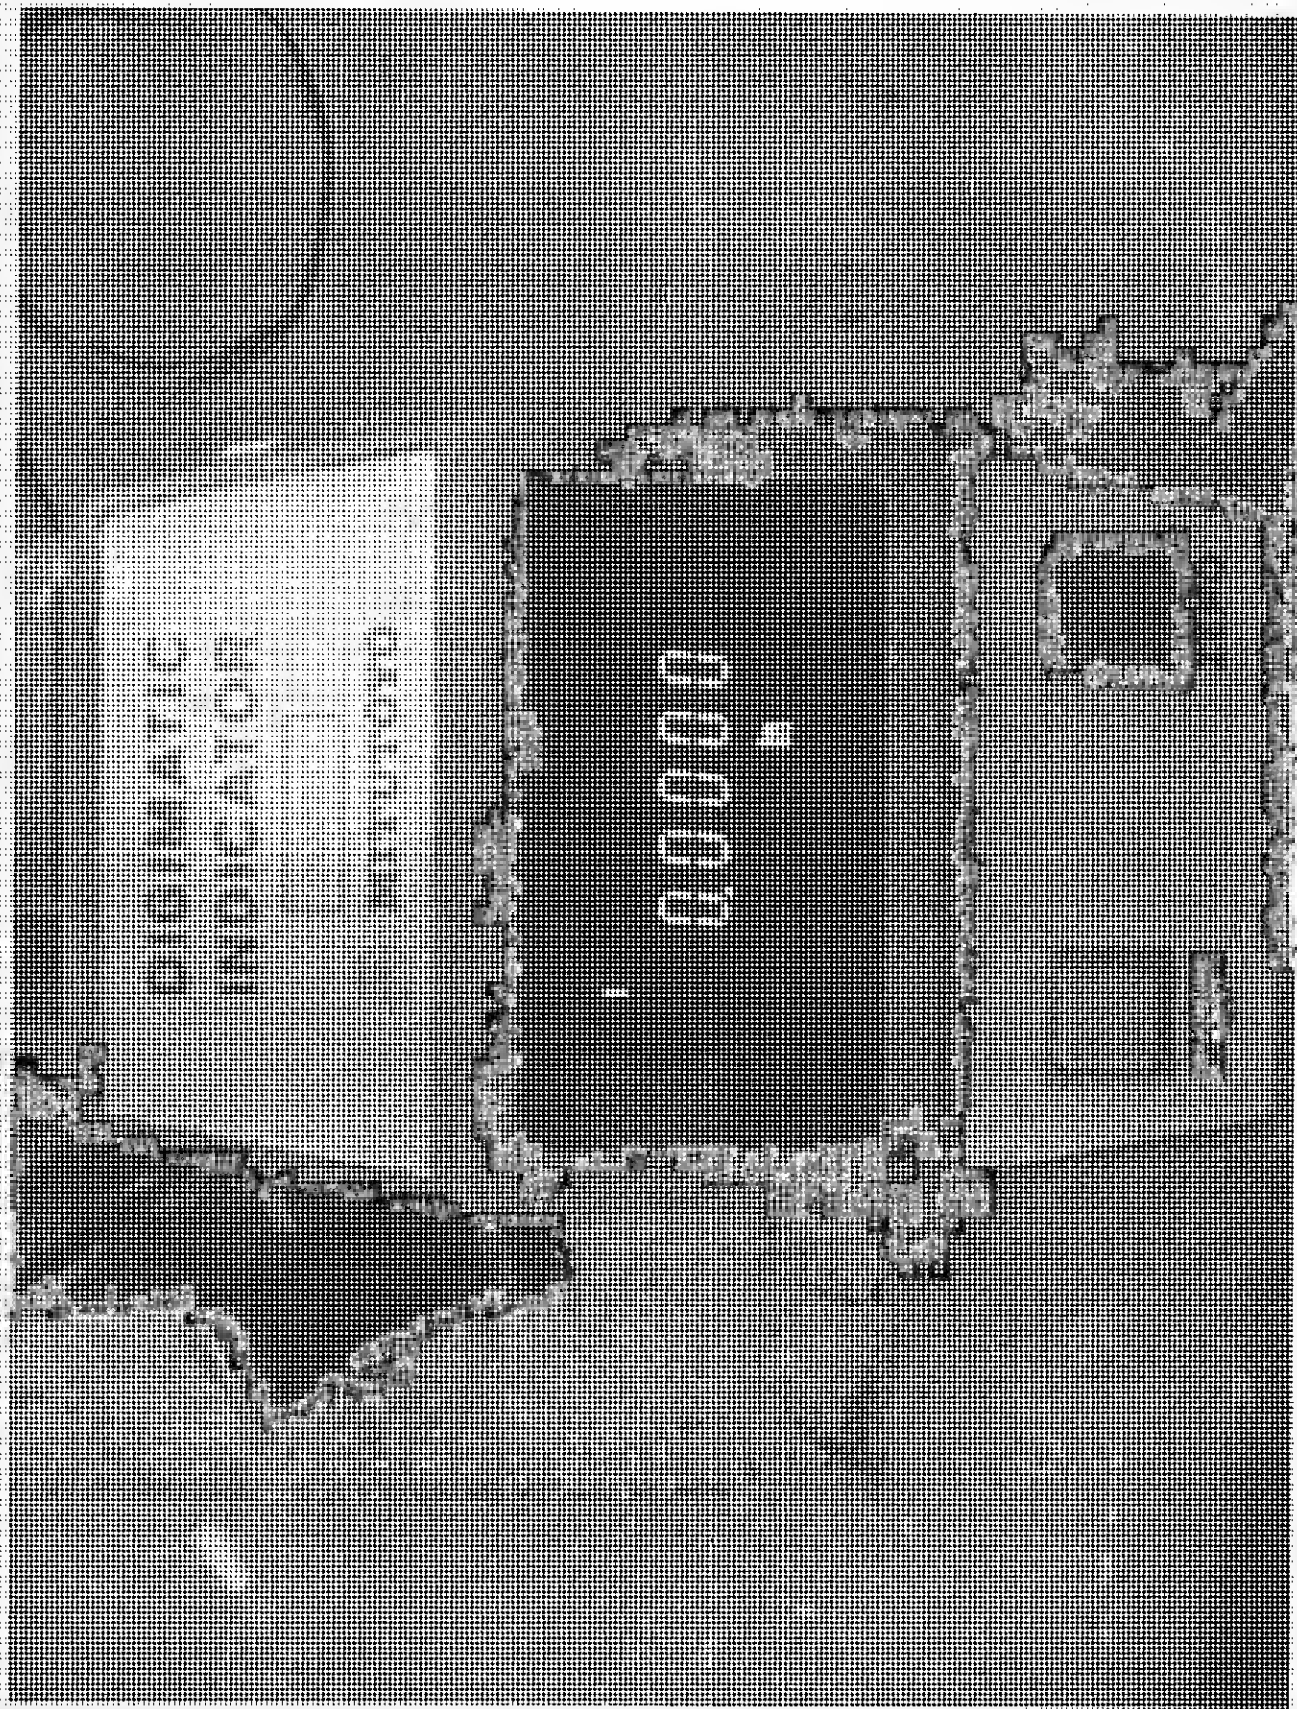
FIGURE 5.14  
DIAL INDICATOR PRE-TEST

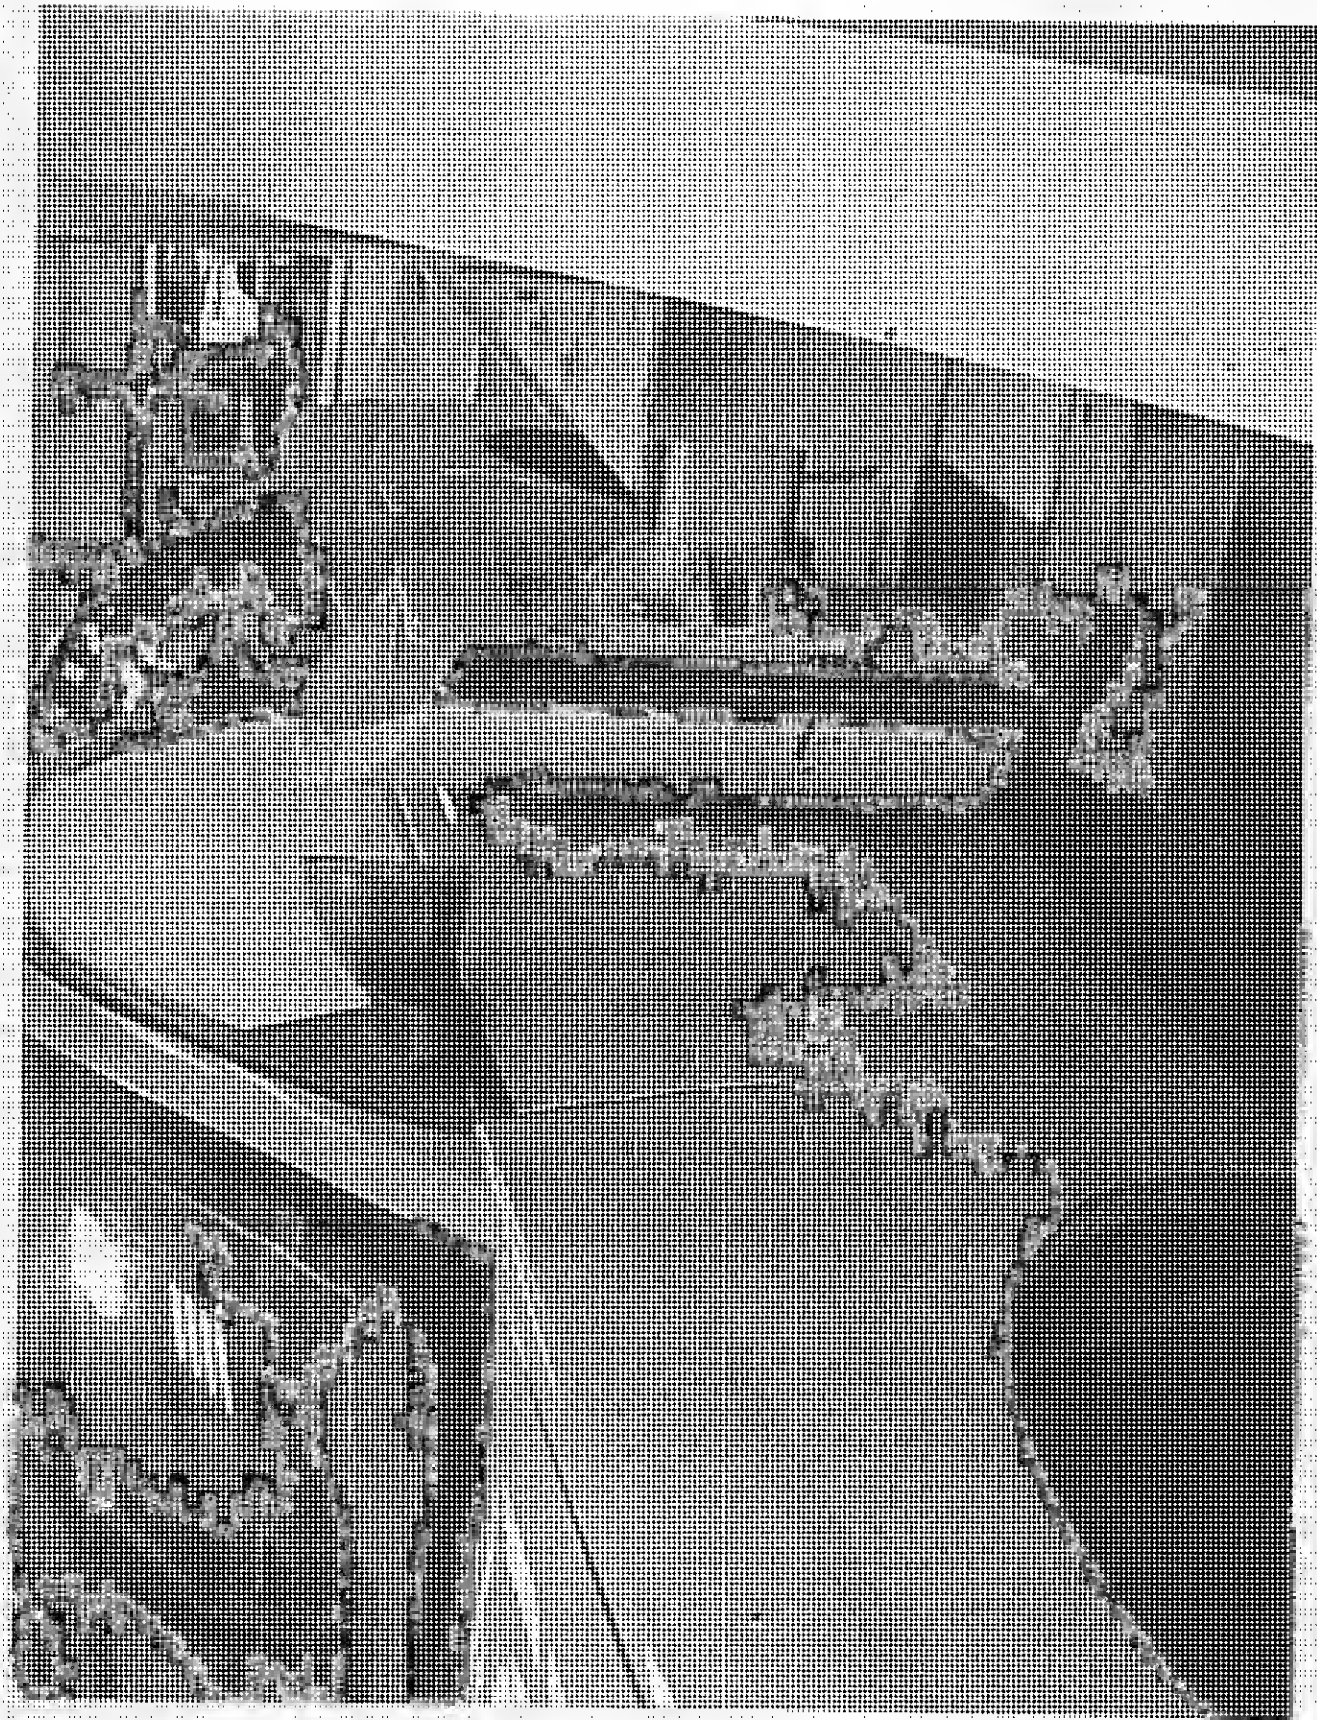
FIGURE 5.15  
LOAD DEVICE AGAINST DOOR - PRE-  
TEST 1

C.	Close all windows	<u>X</u>	<u>X</u>
D.	Lock All doors	<u>X</u>	<u>X</u>
E.	State door tested	<u>LF</u>	<u>RR</u>
F.	State the length of a horizontal line drawn on door through a point 5 inches vertically above lowest point of test door	<u>42.2</u>	<u>27.5</u>

G.	State vertical distance from the lowest part of test door to bottom of loading device	<u>5"</u>	<u>5"</u>
H.	State position of vertical centerline of loading device on the midpoint of line determined step F	<u>21.1</u>	<u>13.25</u>

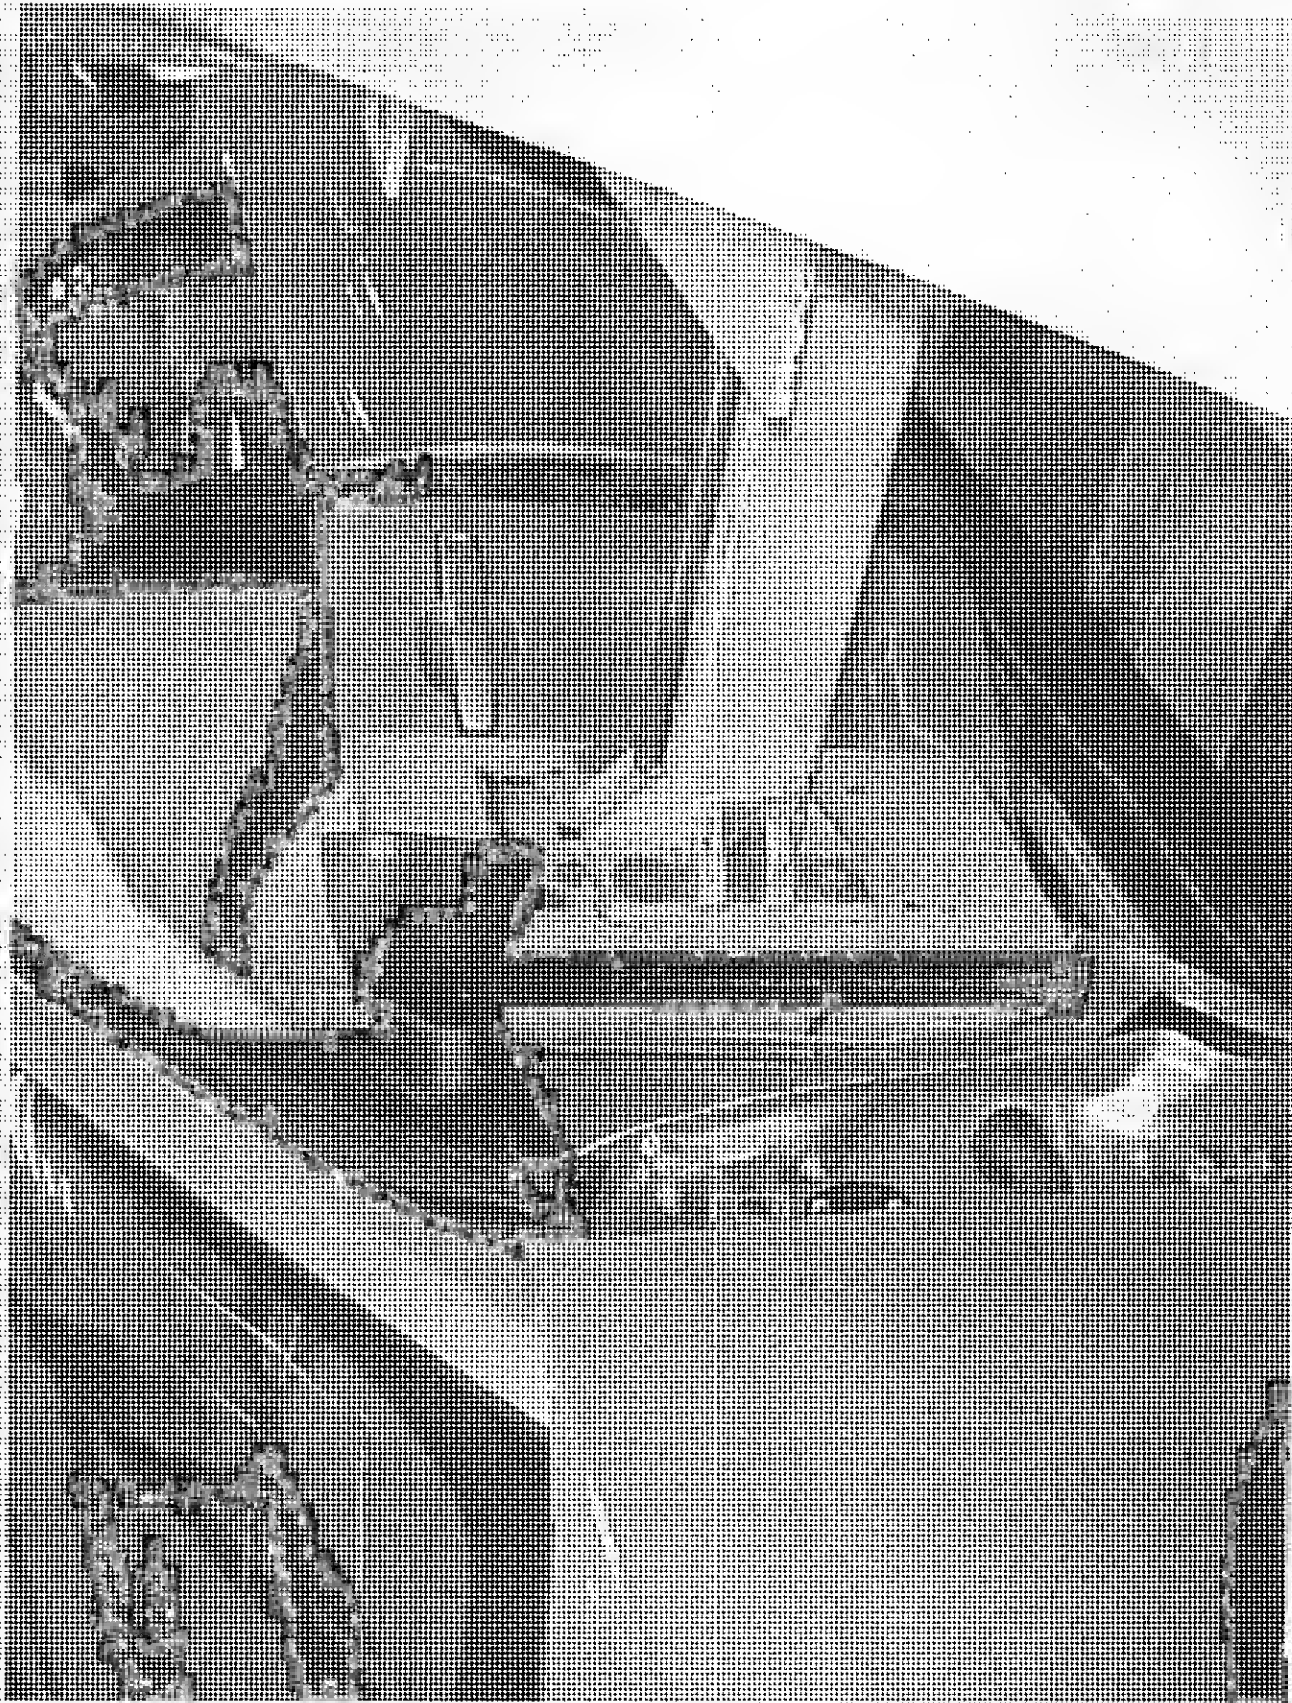
FIGURE 3.16  
LOAD DEVICE AGAINST DOOR @ MAX  
LOAD - TEST 1

- A. The initial crush resistance was 3059 lbs.  
 B. The intermediate crush resistance was 5697 lbs.  
 C. The peak crush resistance was 11,495 lbs at 12.003 inches  
 D. The rate of loading was .2"/sec

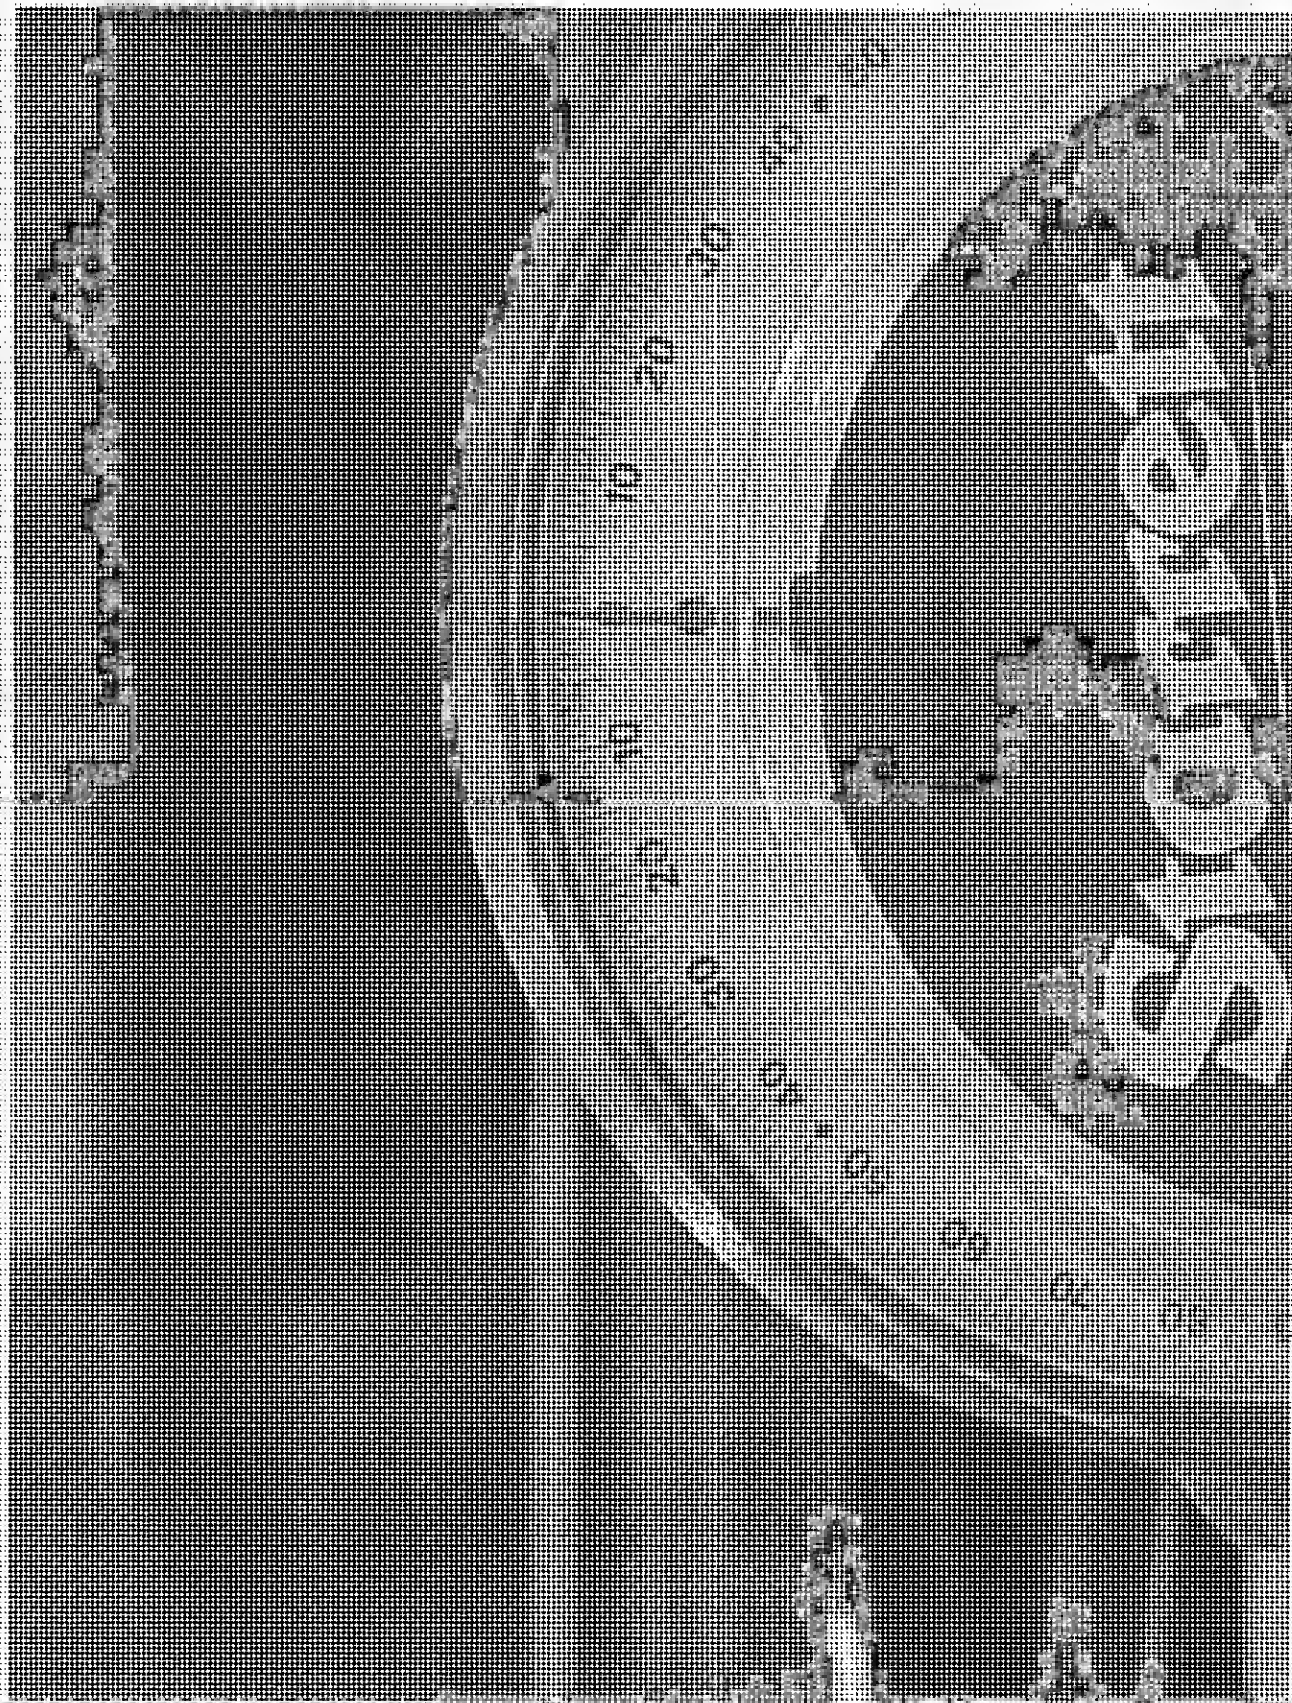
FIGURE 5.17  
INCLINOMETER AT MAX LOAD - TEST 1

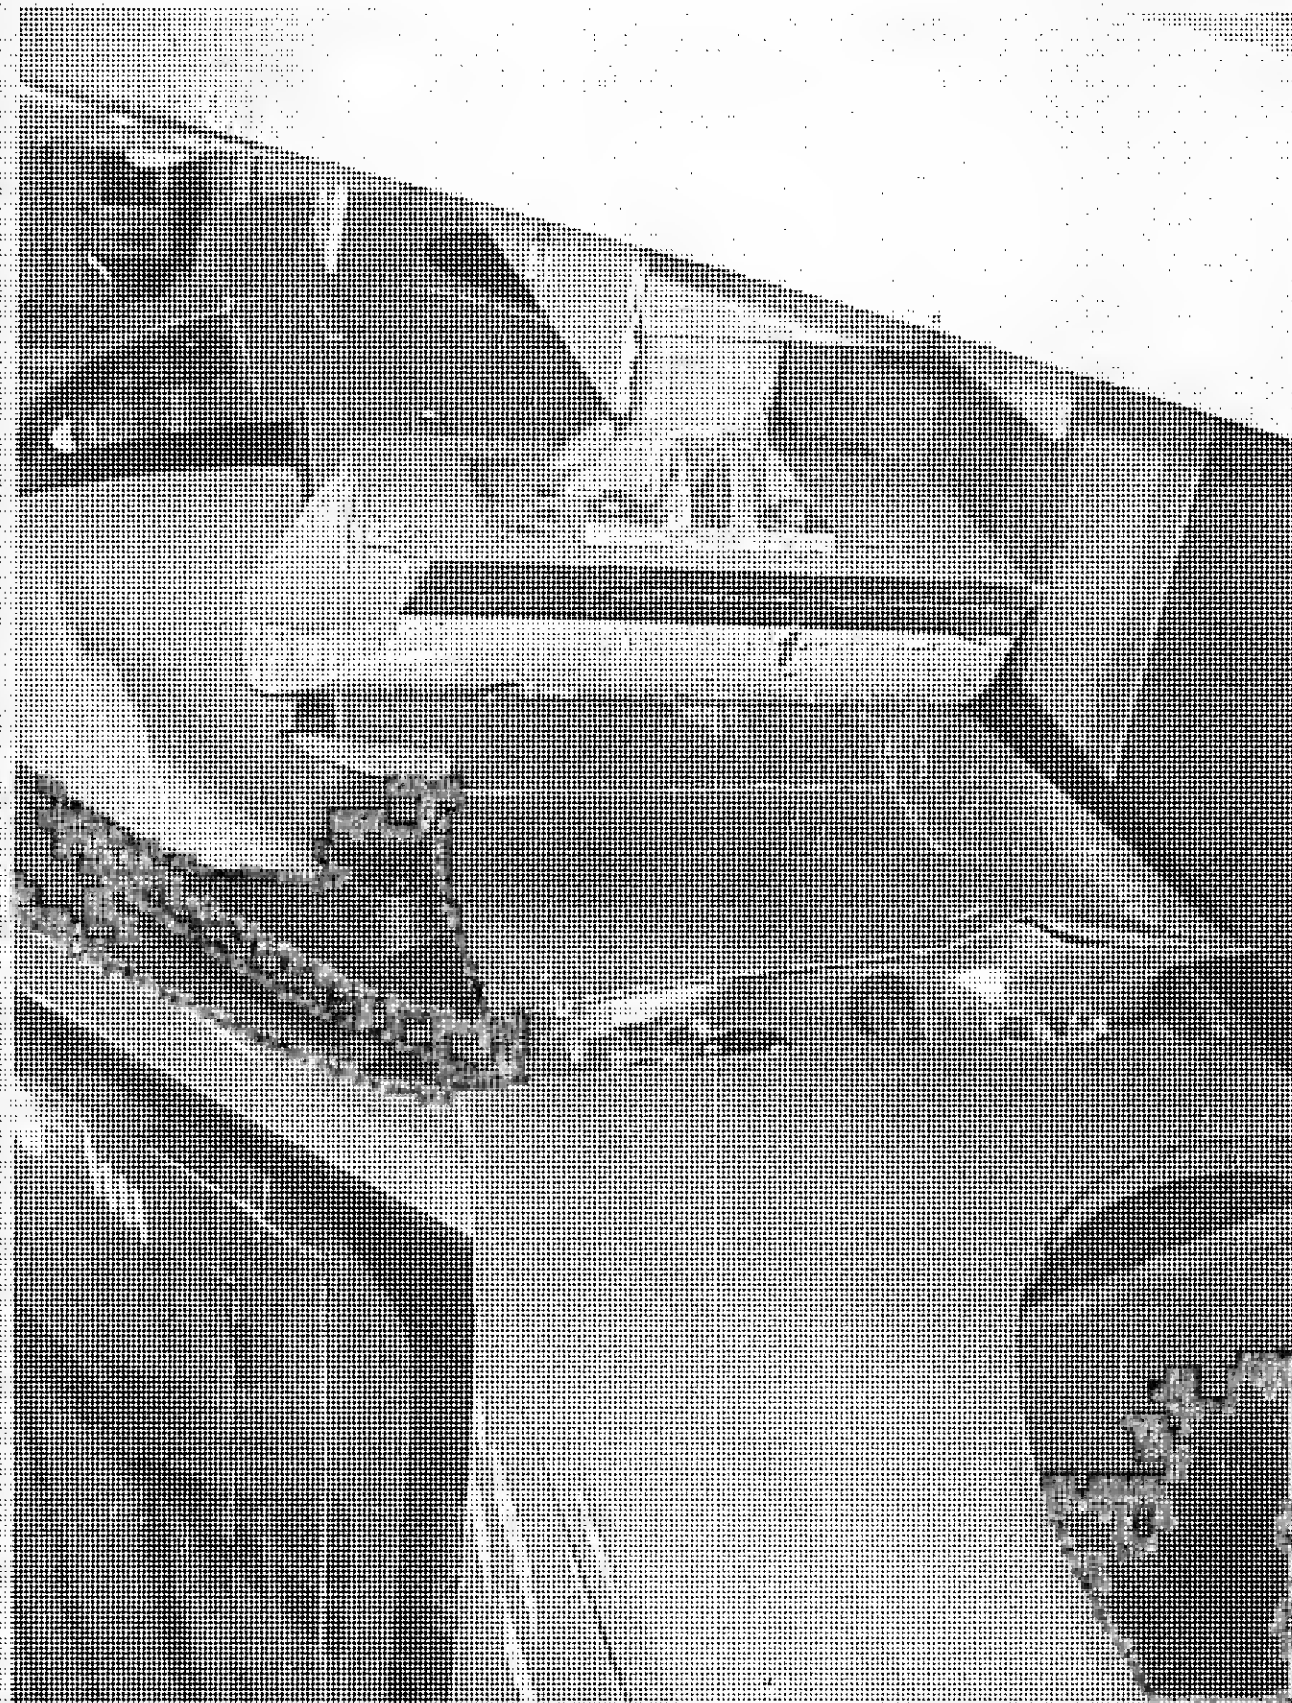
FIGURE 5.19  
POST TEST DOOR OUTSIDE - TEST 1

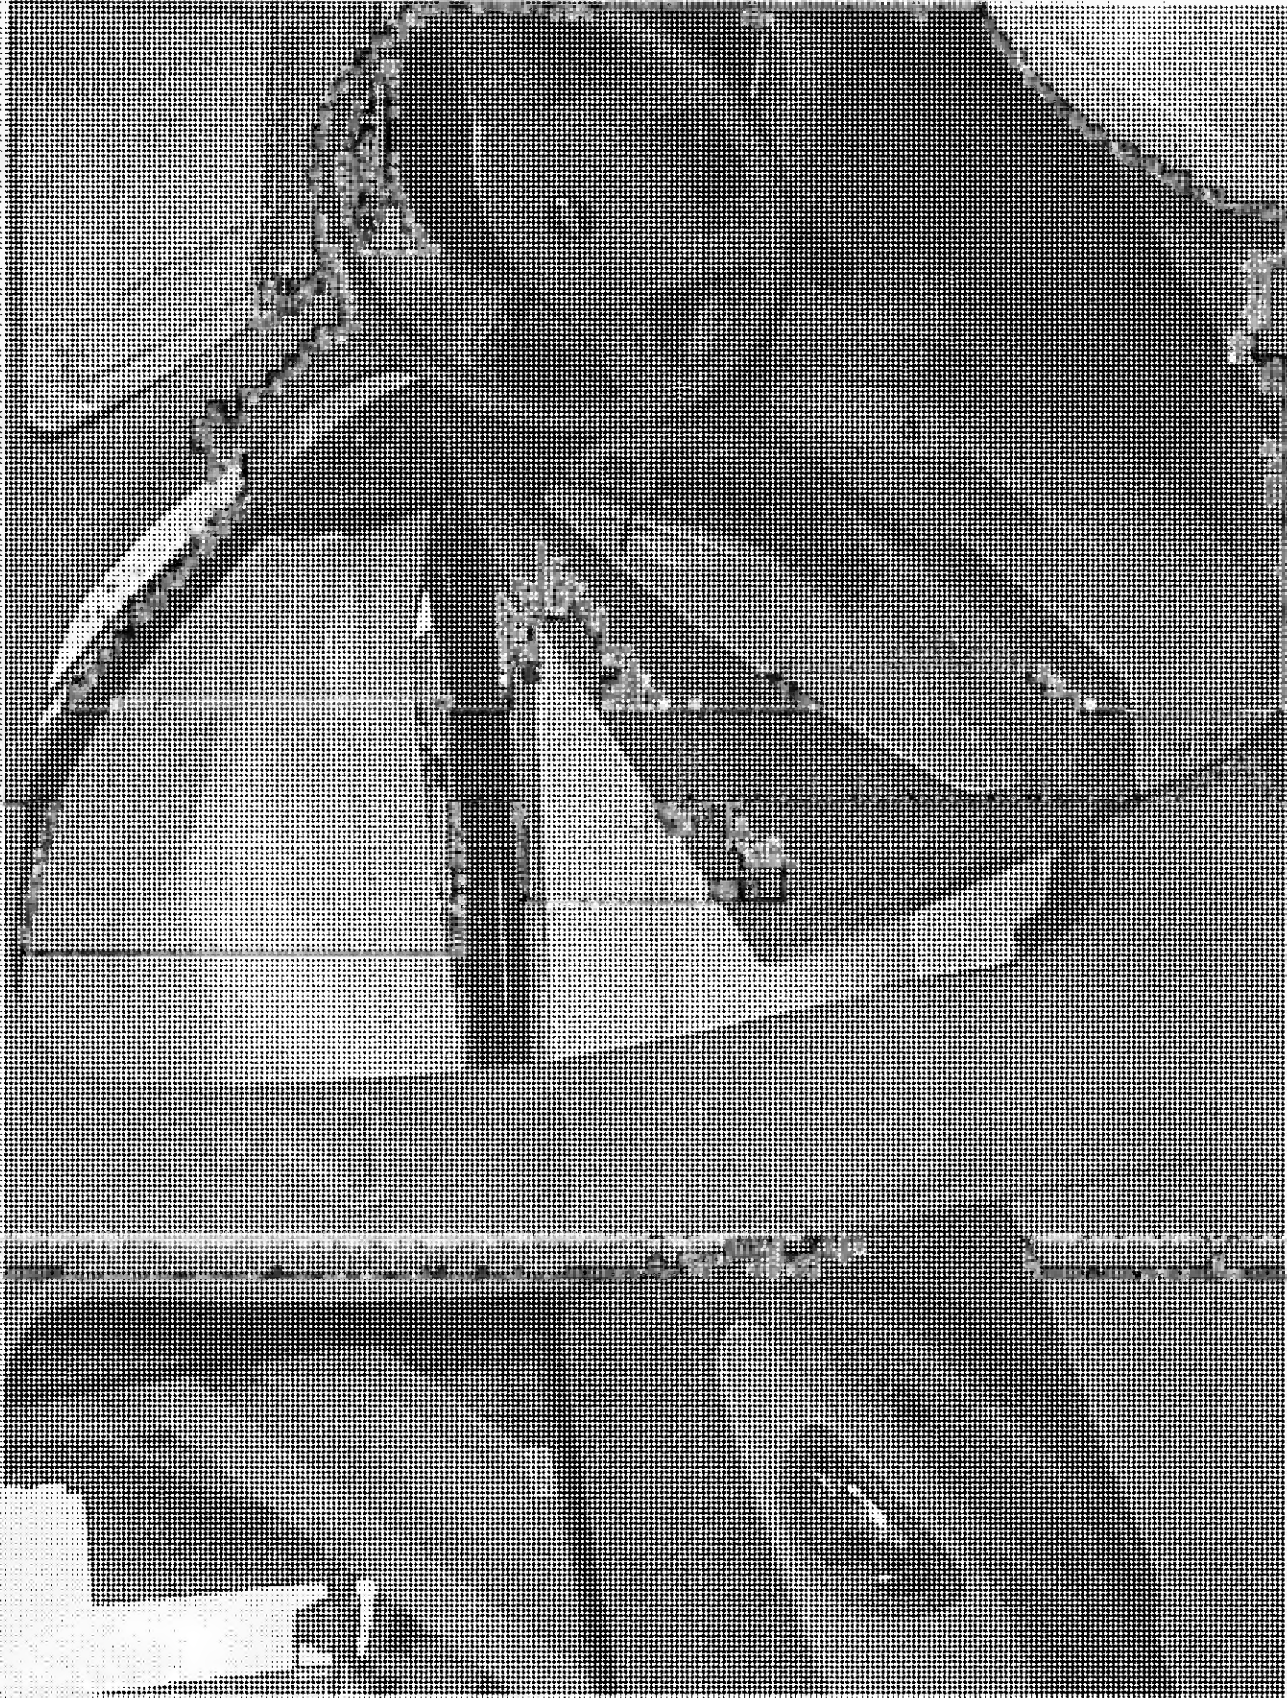
FIGURE 6.20  
POST TEST DOOR INSIDE - TEST 1

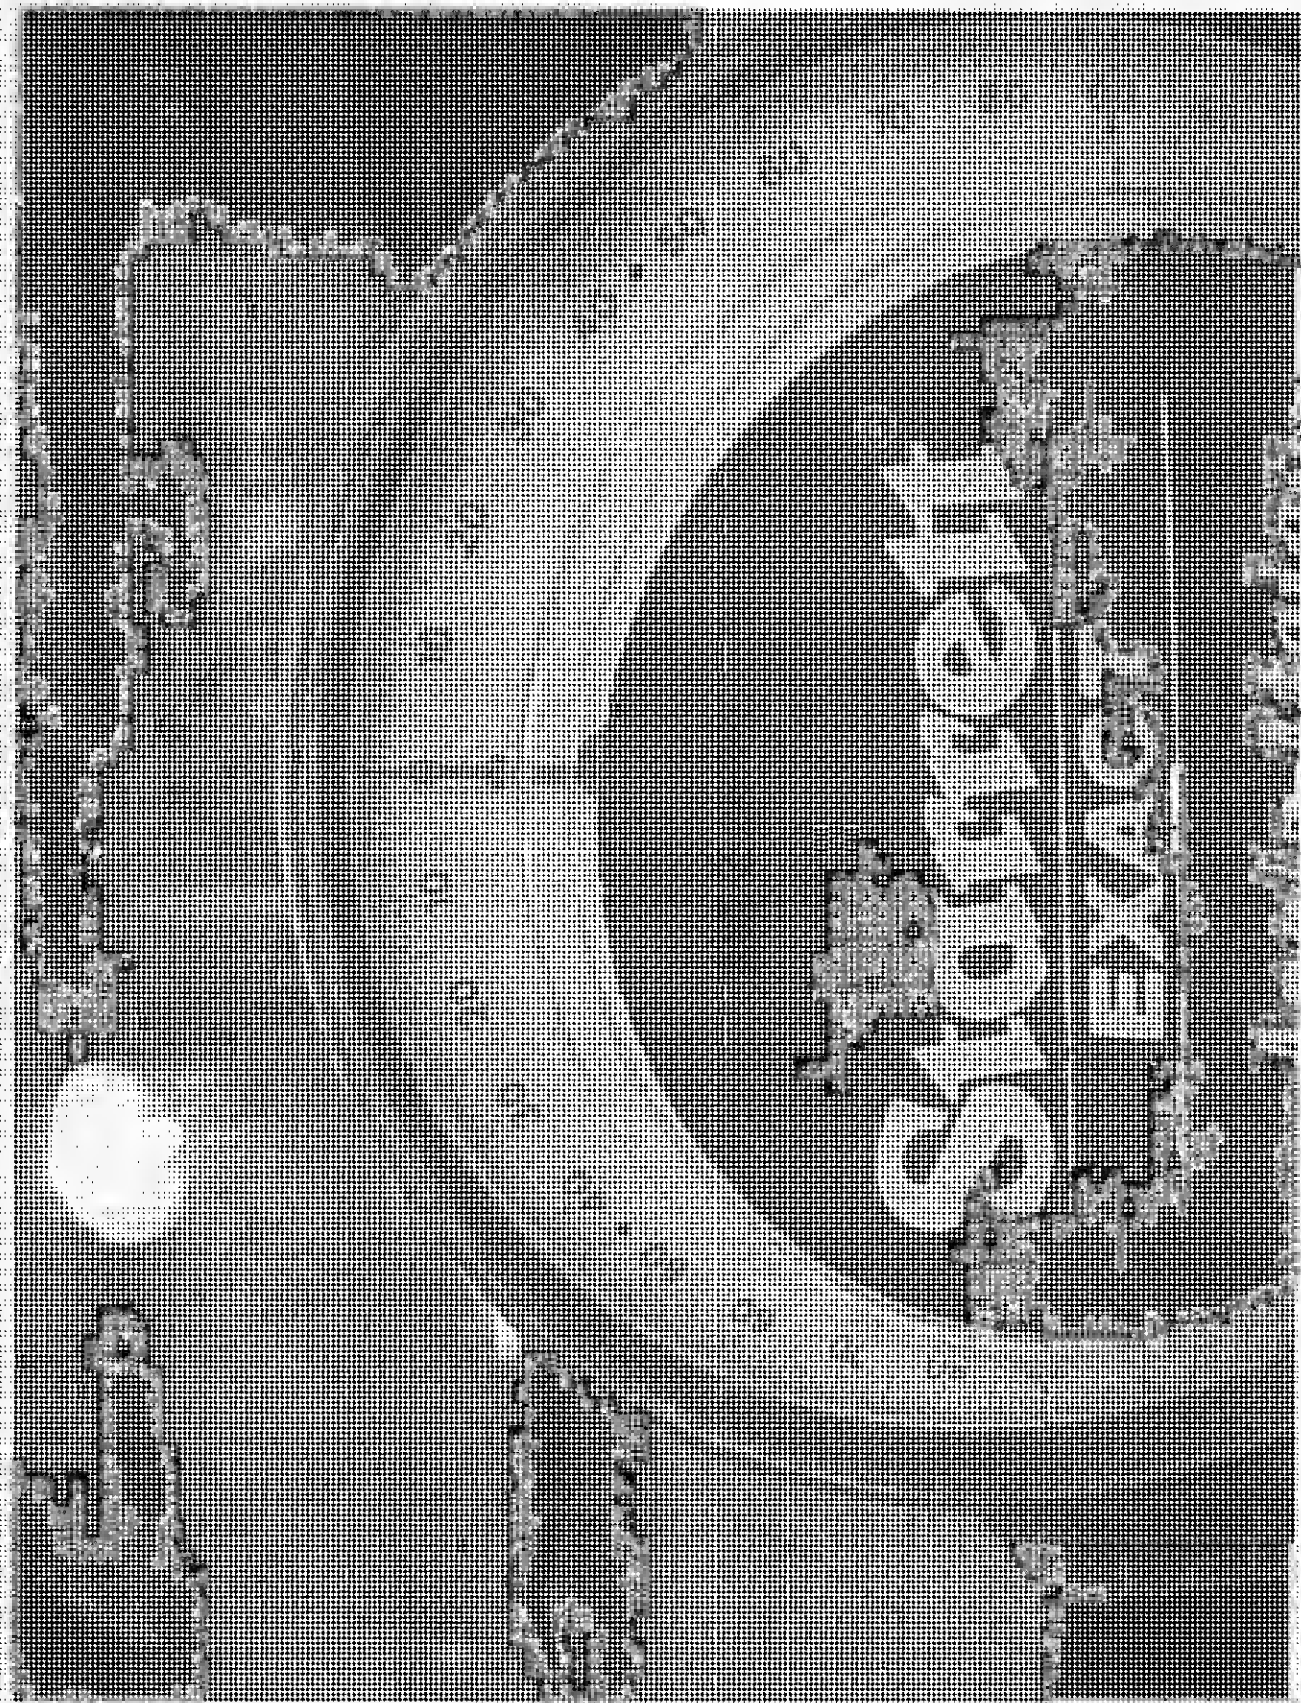
FIGURE 5.23  
INCLINOMETER PRE-TEST 2

LOADING DEVICE TRAVEL	DIAL INDICATOR	INCLINOMETER
0 inches	<u>0.0000</u>	<u>0</u>
2 inches	<u>0.0285</u>	<u>0</u>
4 inches	<u>0.0340</u>	<u>0</u>
6 inches	<u>0.0685</u>	<u>0</u>
12 inches	<u>0.4043</u>	<u>0</u>
<u>12.761</u> Inches (full travel)	<u>0.4043</u>	<u>0</u>

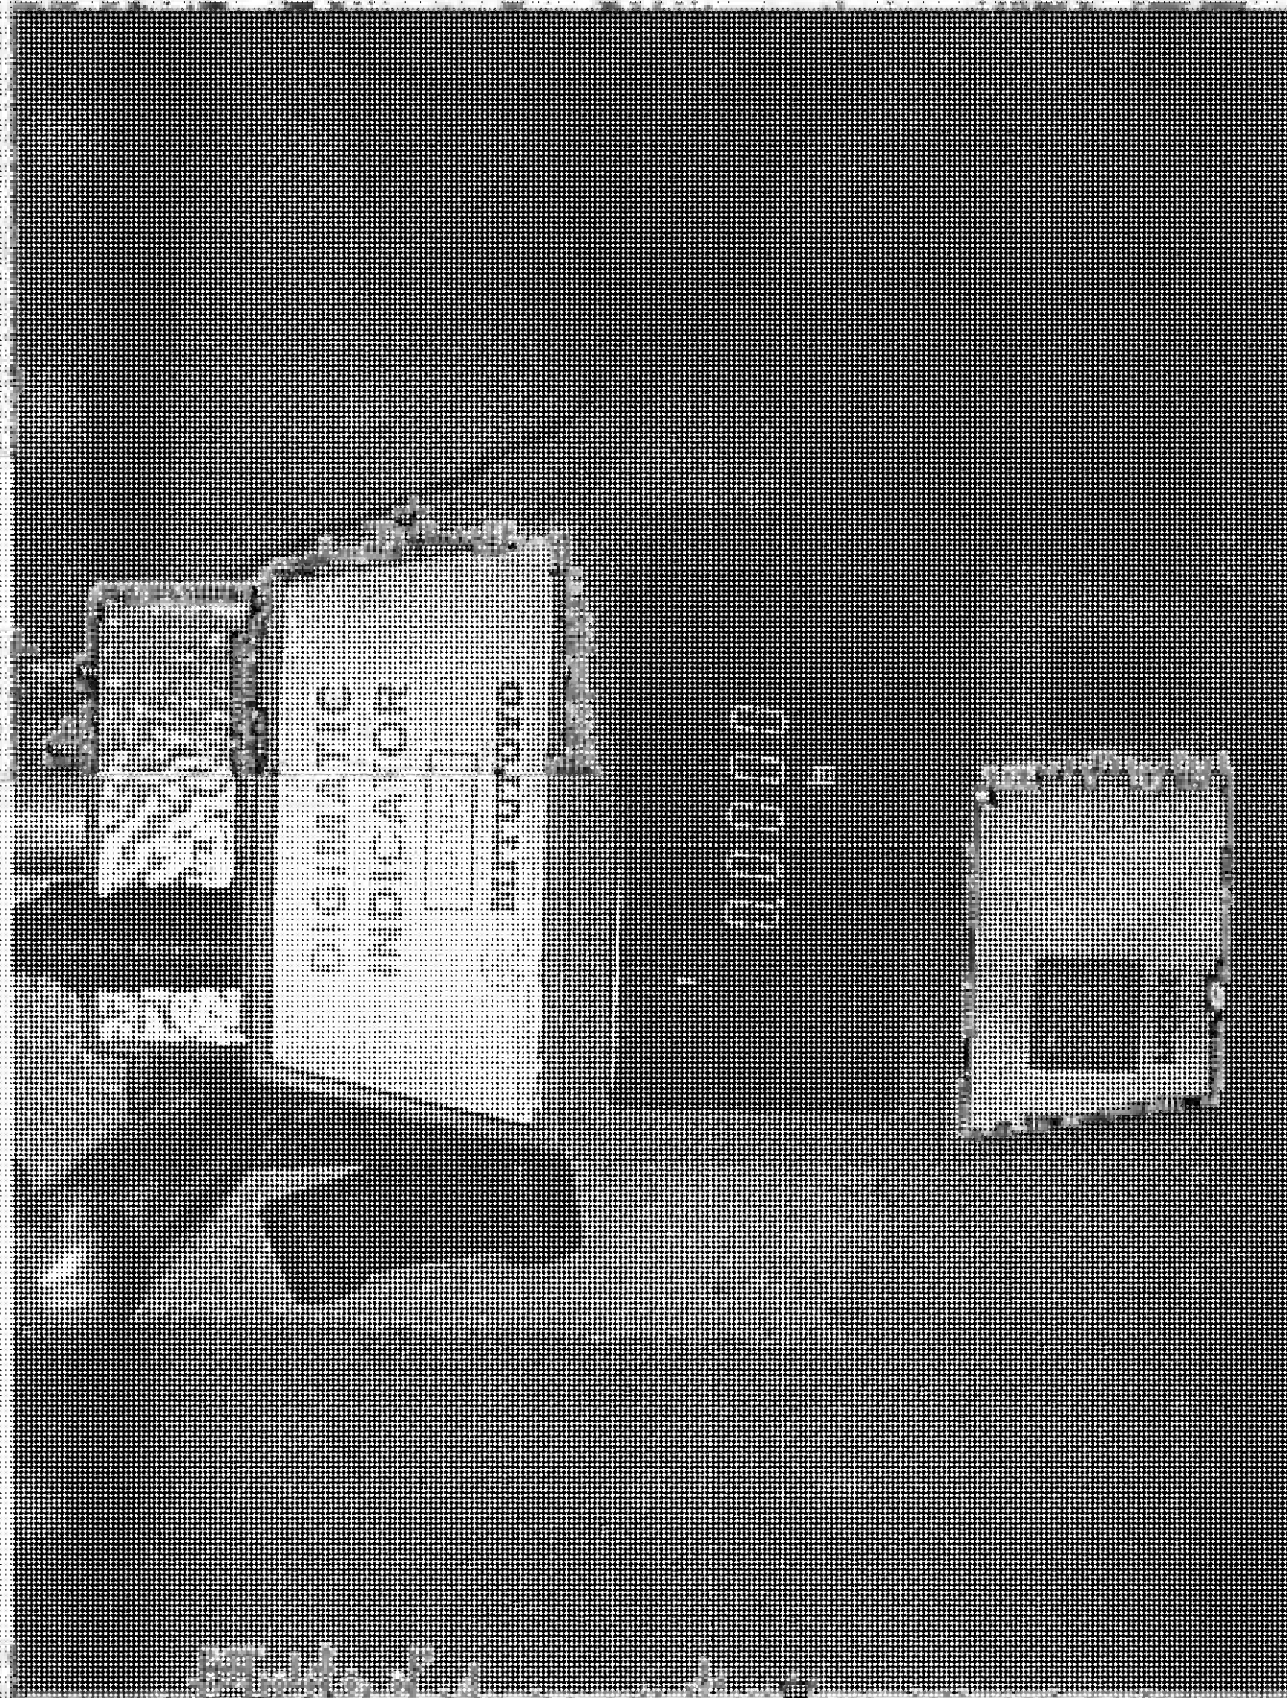
FIGURE 5.24  
DIAL INDICATOR PRE-TEST - 2
